**UNITED STATES ENVIRONMENTAL PROTECTION AGENCY**

**Re: Arconic/Alcoa West Plant – Massena, 45 County Route 42 (Park Ave East)  
EPA Inspection August 30 to September 1, 2017  
SPDES Permit No: NY0001732**

## Water Compliance Inspection Report

<b>Compliance Evaluation Inspection – Massena Operations – Alcoa/Arconic West Plant</b>	
<b>Inspection Date:</b> August 30, 2017 to September 1, 2017 <b>Inspection Time:</b>	<b>EPA Representatives:</b> Murray Lantner, P.E. Environmental Engineer, USEPA Region 2, (212) 637-3976, <a href="mailto:lantner.murray@epa.gov">lantner.murray@epa.gov</a> Peter Bahor, Enforcement Officer, USEPA-HQ, (202) 564-7029, <a href="mailto:bahor.peter@epa.gov">bahor.peter@epa.gov</a>  <b>New York State Department of Environmental Conservation, Region 6 Representative</b> David Rarick, P.E. Environmental Engineer II, 317 Washington Street, Watertown, NY 13601 (315) 785-2513 (office), <a href="mailto:david.rarick@dec.ny.gov">david.rarick@dec.ny.gov</a>
<b>On-Site Arconic or Alcoa Representatives:</b> Tim Long – (315) 764-4914 (office), (315) 842-1783 (cell) – <a href="mailto:Tim.Long@arconic.com">Tim.Long@arconic.com</a> Todd Furnia (315) 764-4916 (office) (315)

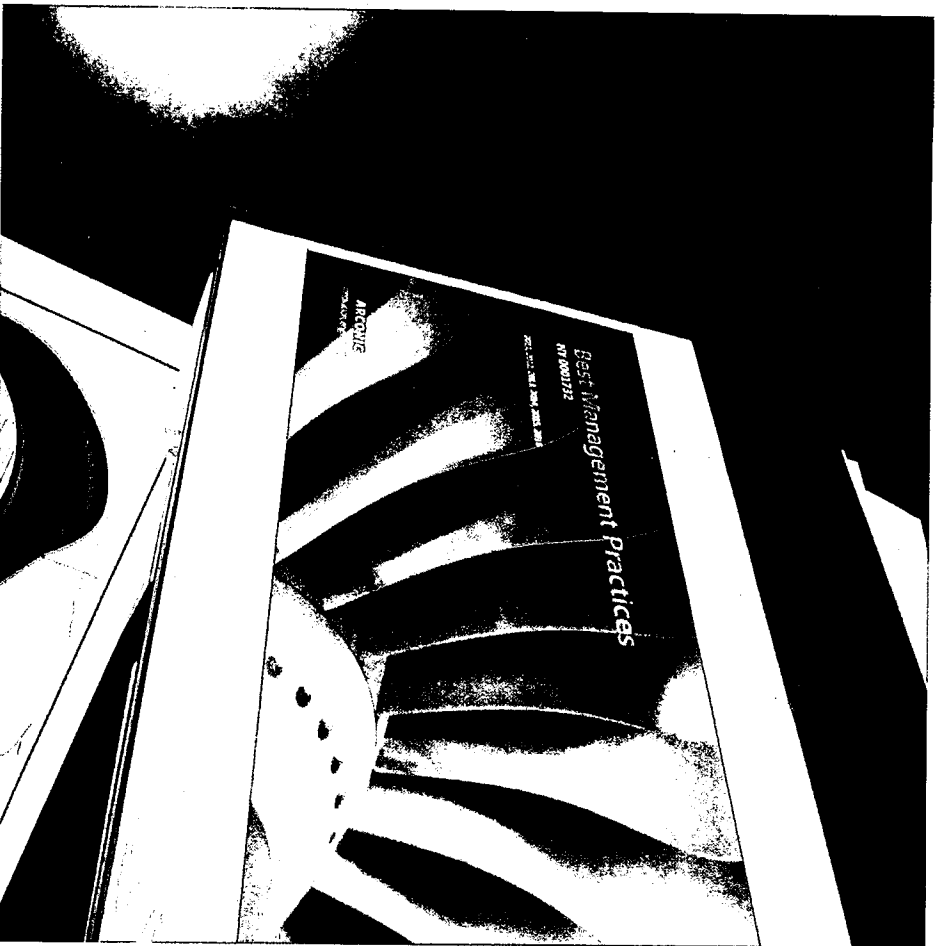
DSCN4853 – Cover Page of BMP Plan

1. As shown in photographs 853 to 855 the Facility has a BMP Plan and it conducts routine BMP inspections. Facility representatives indicated that environmental training is conducted annually (usually in October) for approximately 30 minutes per year. Contractors were said to also take training
2. Four hour composite samples are said to be composited every 30 minutes as per special condition C. (Outfalls 1, 3, 4, 7, and 8)
3. Review of the June 2017 DMR and accompanying reports indicate that PCBs were non-detect at <65 ppb at the Area III impoundment influent and effluent.

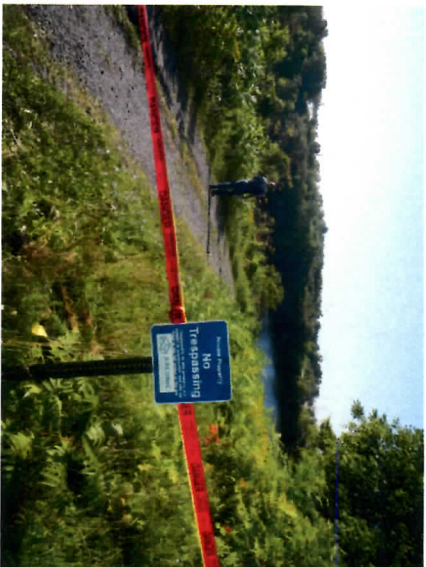
Outfall 004 not accessed – asbestos removal - DSCN0165

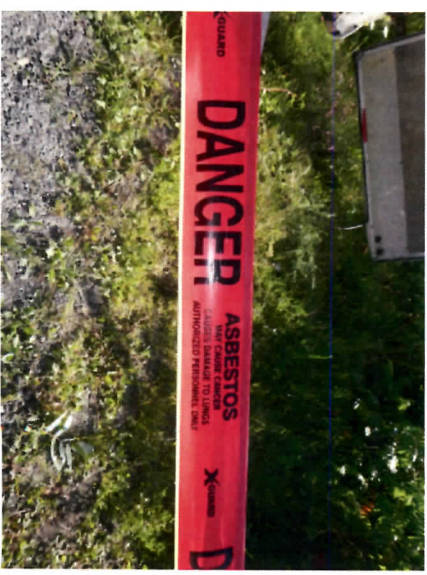
Outfall 004– asbestos removal - DSCN0166

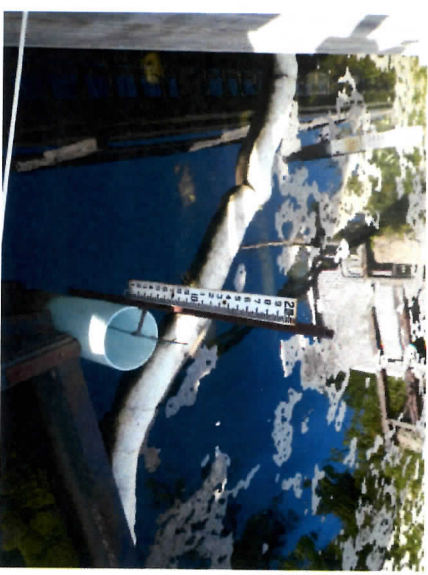
Outfall 001 w/staff guage - DSCN0168

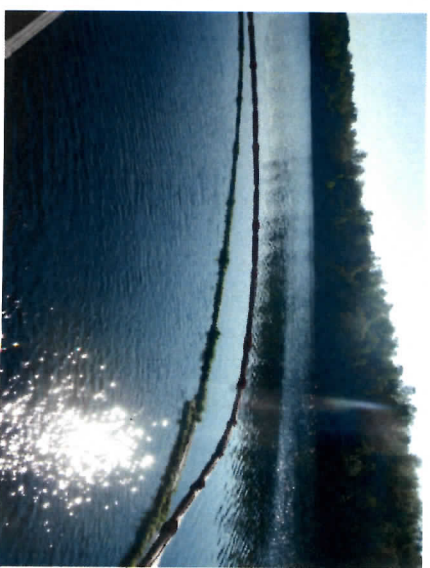
Outfall 001 - w/oil boom - DSCN0170

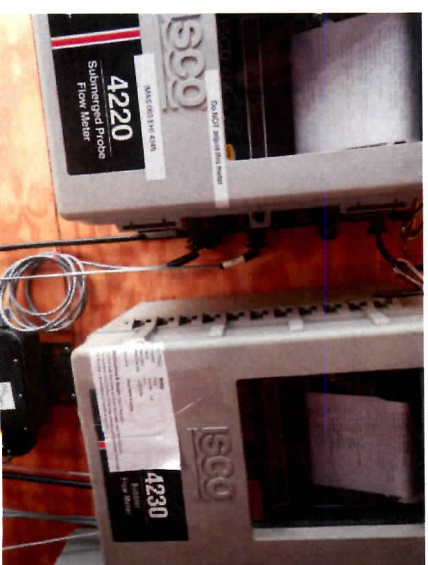
Flowmeter recorders - DSCN0174

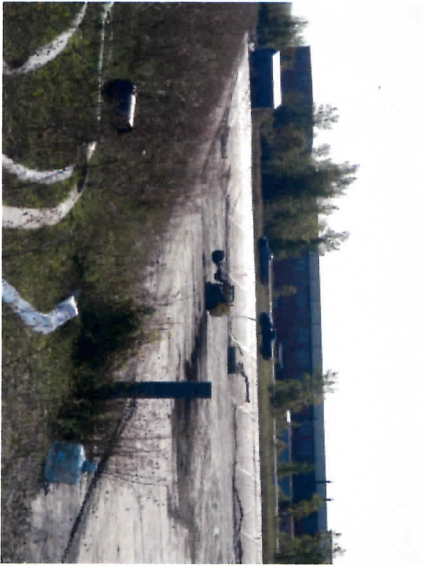
Cleaning out of Cell of Central Impoundment- DSCN0201

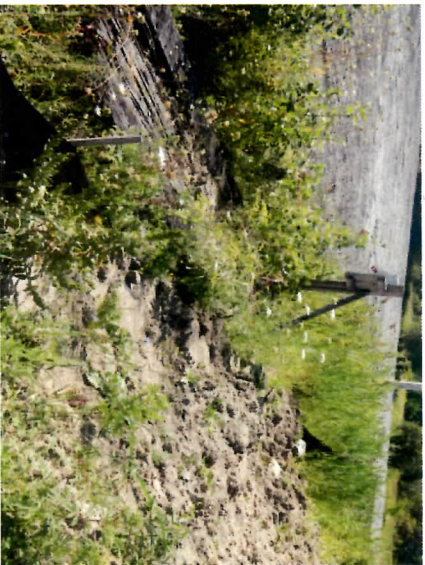
Silt Fence not maintained - DSCN0203

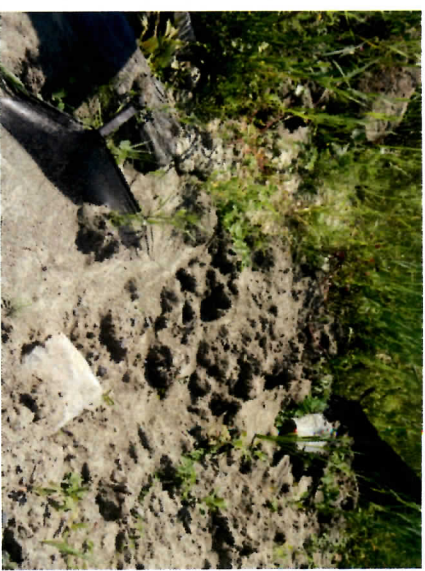
Silt Fence not maintained - DSCN0204

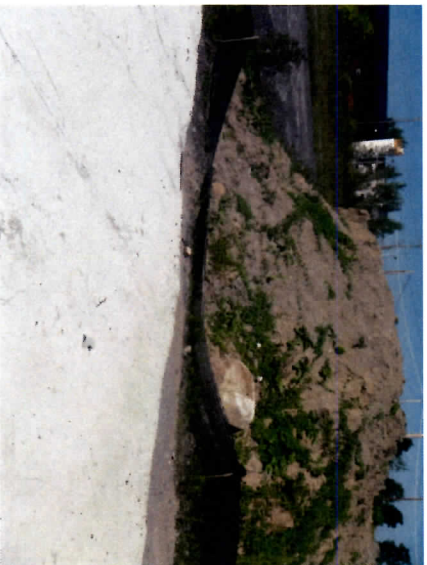
Silt Fence Not Maintained - DSCN0205

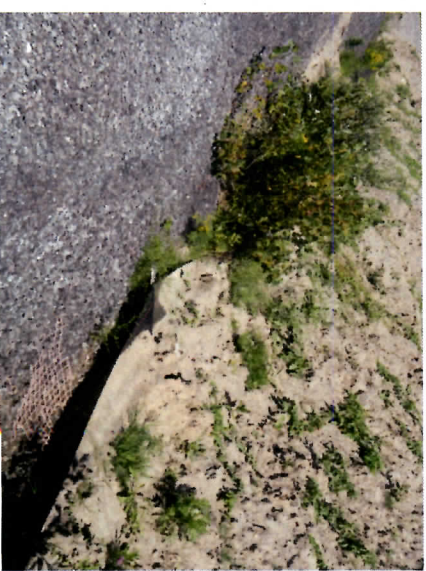
Silt Fence not maintained - DSCN0206

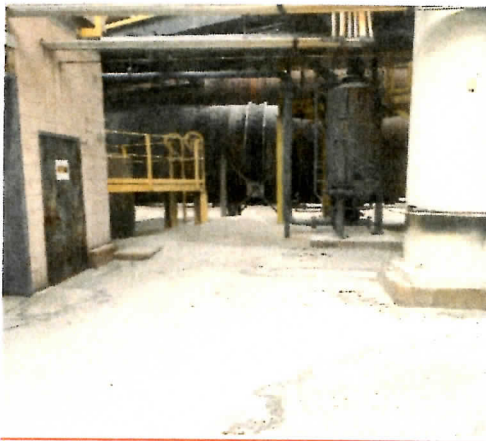
Court yards **N**

These photos are typical of court yards, material is making it to drain...Some look better from the last inspection, Thank you

Drain pyramids' have been installed in some locations

**Is there a plan to complete all courtyards?**

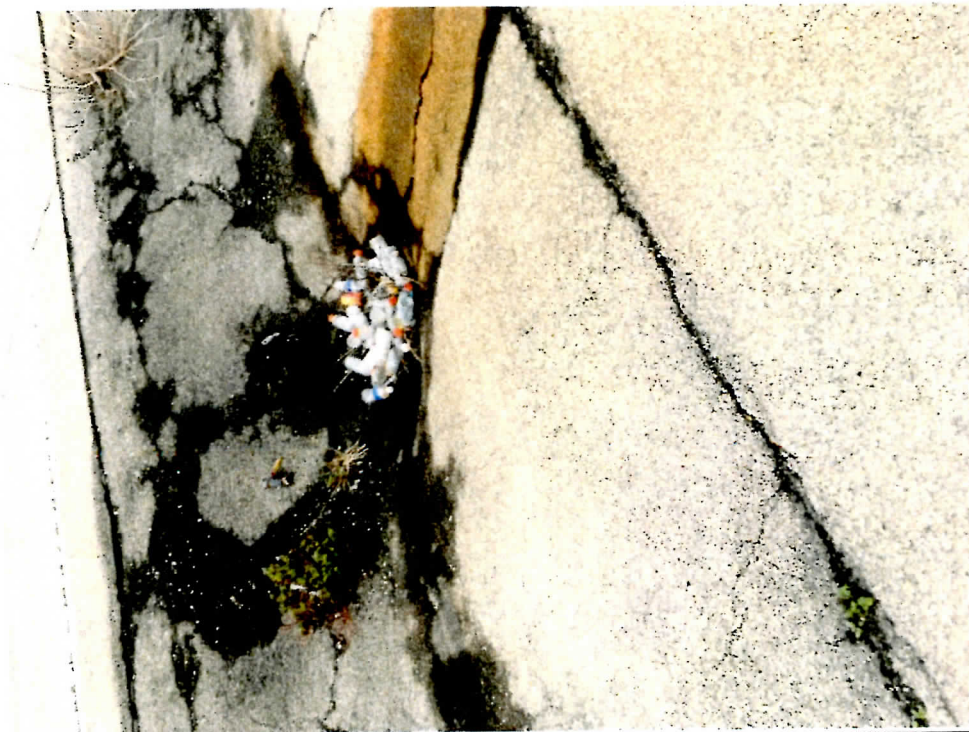
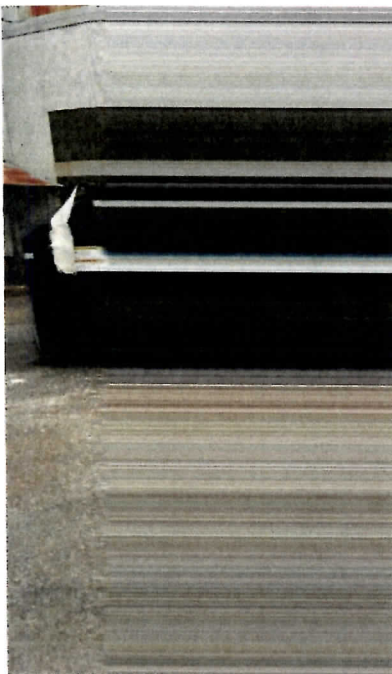
**Waste boxes?** **N** **Bottles at drains, dumpsters with bath material on ground**

**Oily equipment or oily debris** **Y**

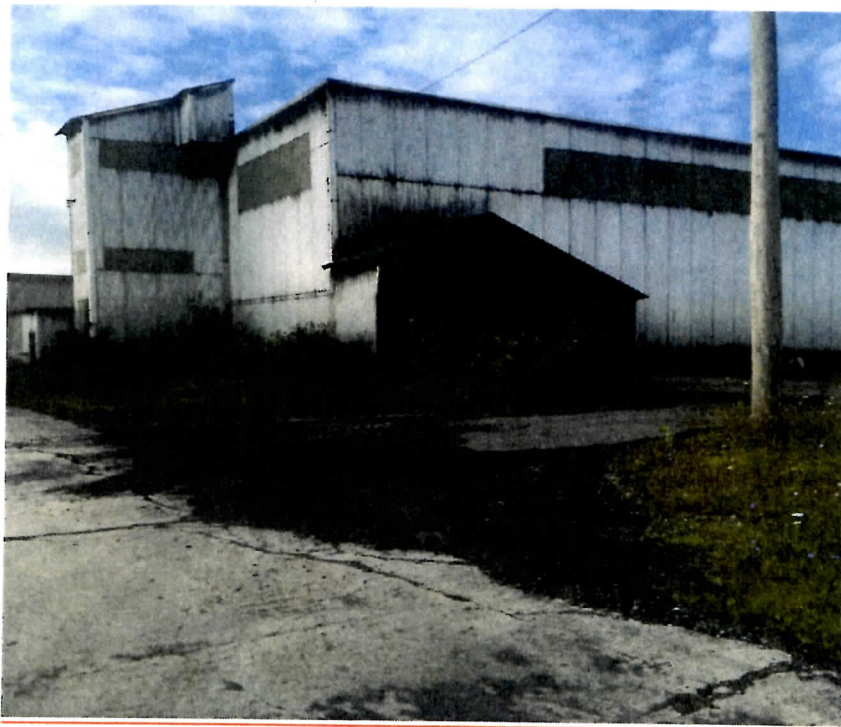
**Coke/Pitch storage area N**

**THIS HAS BEEN IDENTIFIED IN MULTIPLE INSPECTIONS**

**Please close this door as it is allowing carbon dust to escape to the air and ground!!!!**
